DEPARTMENT OF TRANSPORTATION

Quality Assurance and Source Inspection

Contract #: 04-0120F4Cty: SF/ALA Rte: 80 PM: 13.2/13.9File #: 69.28**WELDING INSPECTION REPORT****Resident Engineer:**Pursell, Gary**Address:** 333 Burma Road**City:** Oakland, CA 94607**Report No:** WIR-013206**Date Inspected:** 19-Feb-2010**Project Name:** SAS Superstructure**OSM Arrival Time:** 7000**Prime Contractor:** American Bridge/Fluor Enterprises, a JV**OSM Departure Time:** 1900**Contractor:** Zhenhua Port Machinery Company, Ltd (ZPMC), Changxing Island **Location:** Shanghai, China

Bridge No: 34-0006**Component:** OBG Components**Summary of Items Observed:**

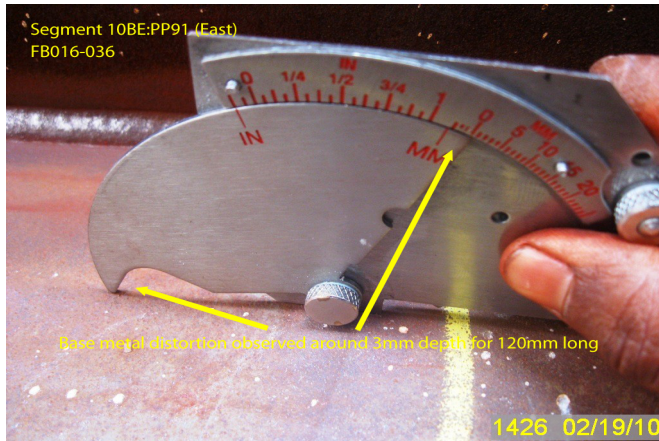
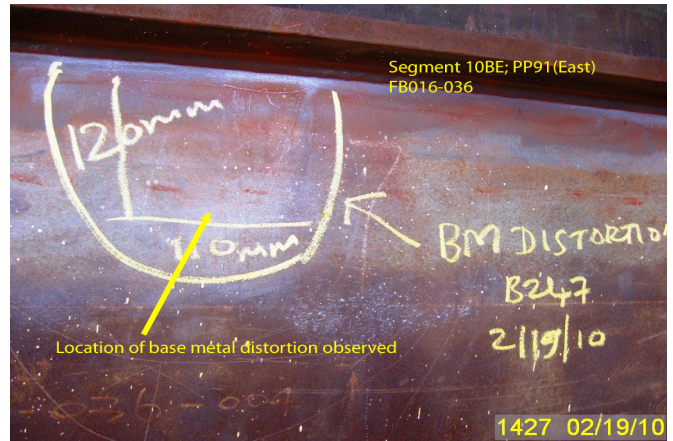
During visual inspection of segment 10BE this QA inspector observed that PP91 (East) FB016-036,

Base metal distortion 3mm in depth and 120mm long. This is marked on that location for future ZPMC reference and rectification. For more information please see the attached photos
